# RAILROAD COMMISSION OF TEXAS

**RE:** Weesatche Project, Goliad County  
Uranium Exploration Permit No. 123B  
**Inspection Report**

### URANIUM EXPLORATION INSPECTION REPORT

Project Name: Weesatche Permit Number: 123B

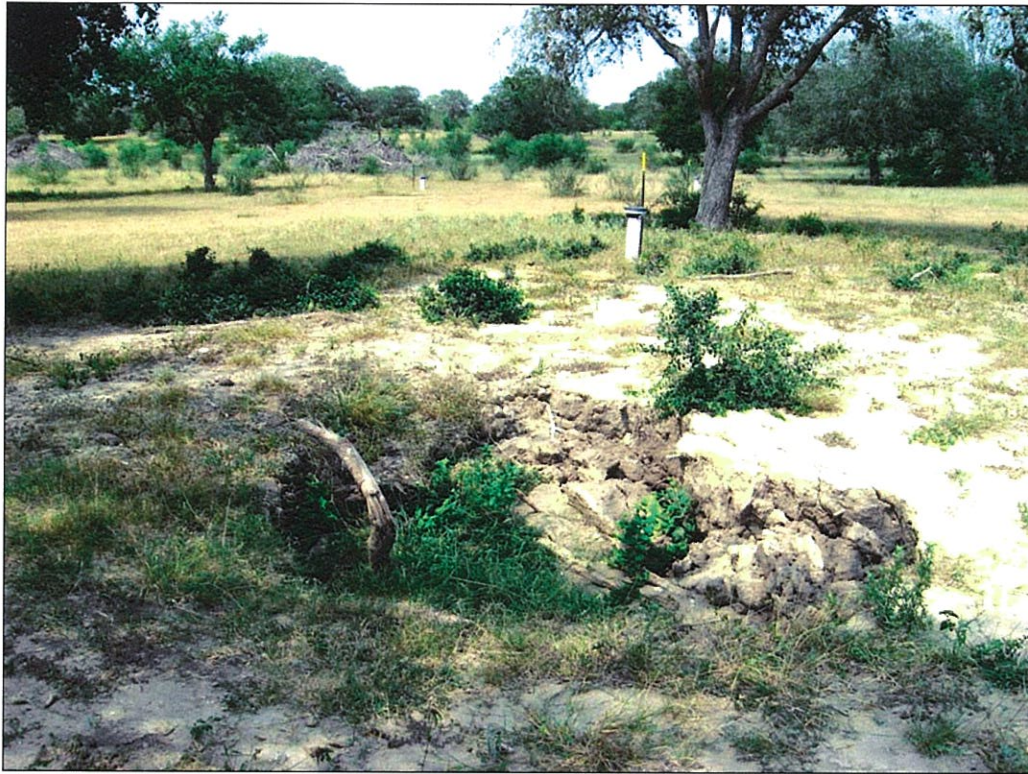
This inspection of UEC Permit No. 123 focused on site restoration follow up on the Braquet section of the permitted exploration area. A subsided mud pit was located near an array of cased wells, as documented in Photo 1, pointing out the need for on-going monitoring of mud pits for this type problem as this area had been examined relatively recently with no subsidence noted. Numerous cased well and exploration borehole locations were examined with no further evidence of subsidence issues. Examples of typical site restoration efforts around cased wells are documented in Photos 2-3, where the cased wells were found to be properly secured with the casing capped or flanged closed with locks in many cases. The area surrounding the un-inhabited houses on the Braquet property was inspected as there were numerous drilling locations in close proximity to these structures as seen in Photos 4-5. Little evidence of exploration activity was currently visible near the houses during a circle of the area as documented in Photo 6. A field with numerous exploration boreholes to the north of the Ander church and cemetery was inspected on 5-21-08 and a typical example of the site restoration efforts at that time of borehole N-16 is seen in Photo 7. There remains little evidence of exploration activity in this field as documented in Photo 8 in which the church and cemetery are clearly visible. Despite the near 3 inches of rain noted during the May inspection at Permit No. 123, persistent drought conditions continue to hamper re-vegetation as seen in Photos 8-10. The drilling locations of boreholes N-255 and CC-4 were well vegetated on 7-16-08 but are seen to be significantly less so currently.

Photo 1: Subsided mud pit near cased well on Braquet lease.

UEC representative James Gale stated that the subsided mud pit noted would be attended to as soon as possible and other areas examined for other instances of this type.

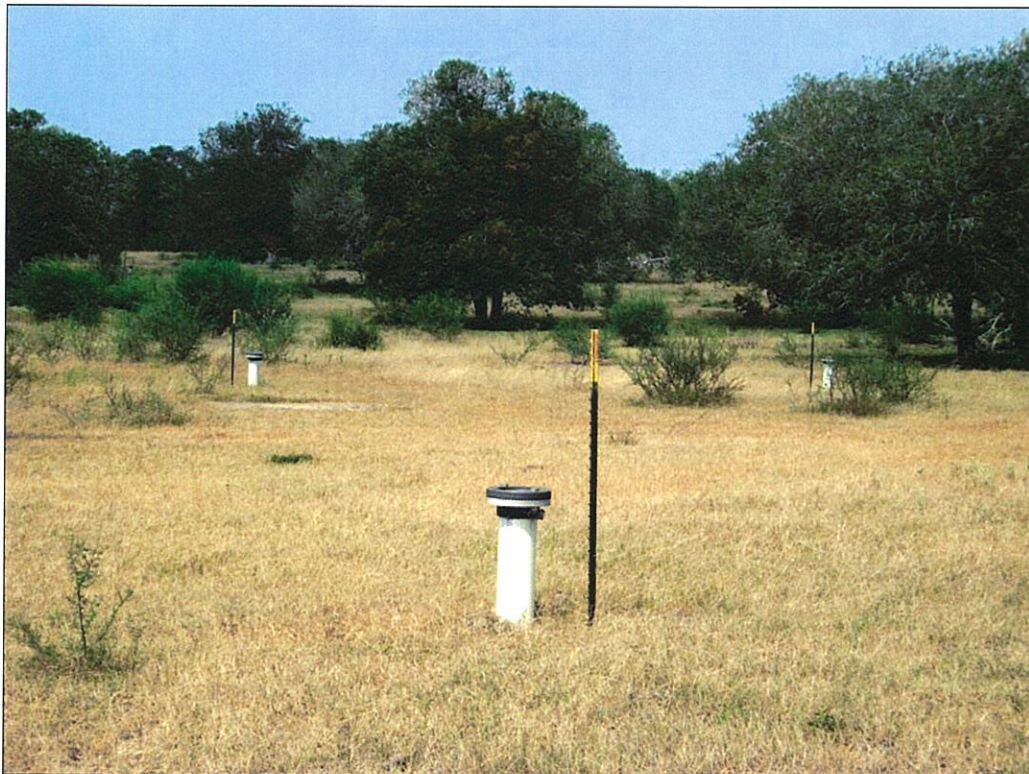
Photo 2: Site restoration of cased wells on Braquet property.

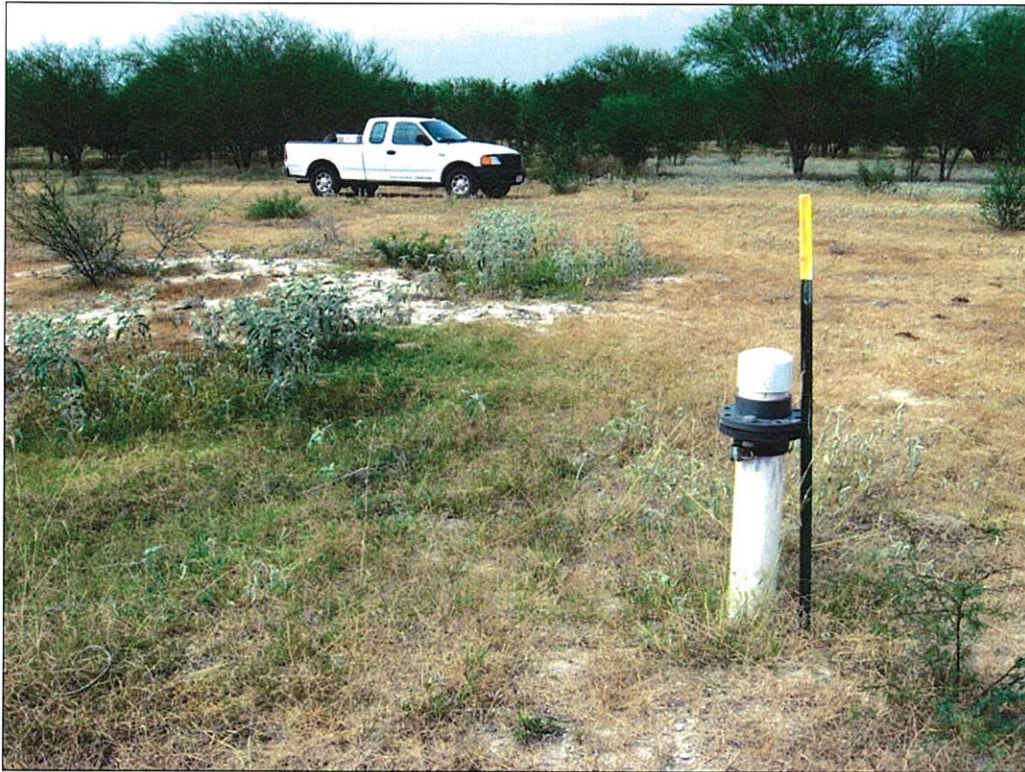
Photo 3: Cased well properly secured with cap locked on.

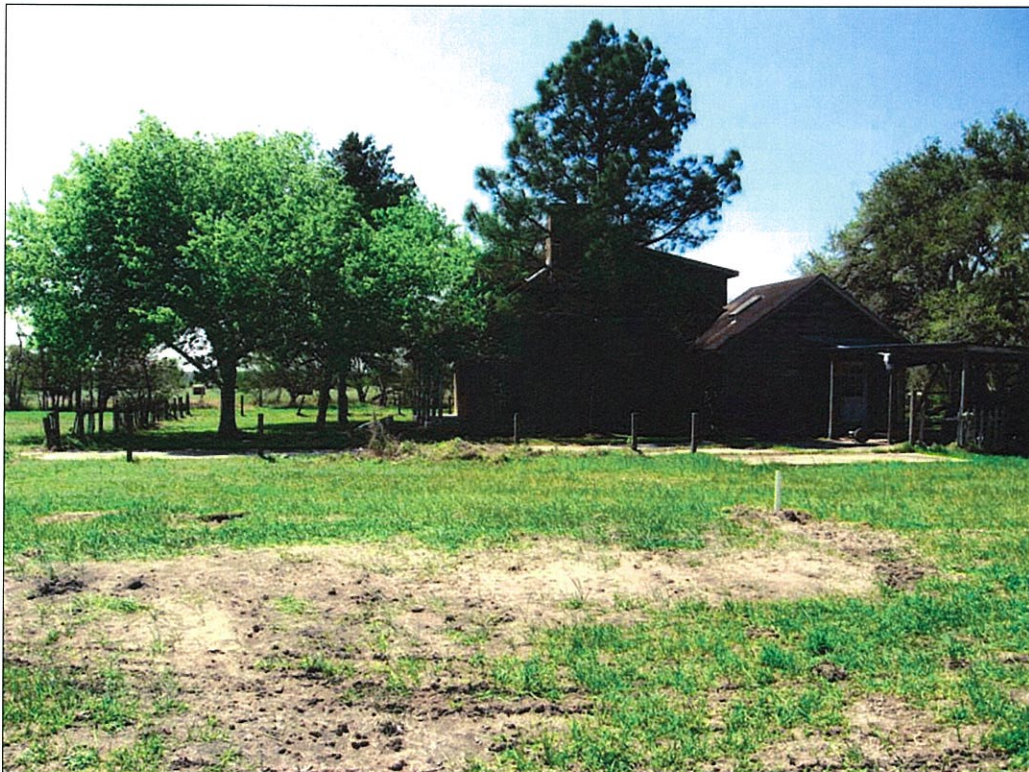
Photo 3: Exploration drilling location near old house on Braquet lease on 3-19-08.

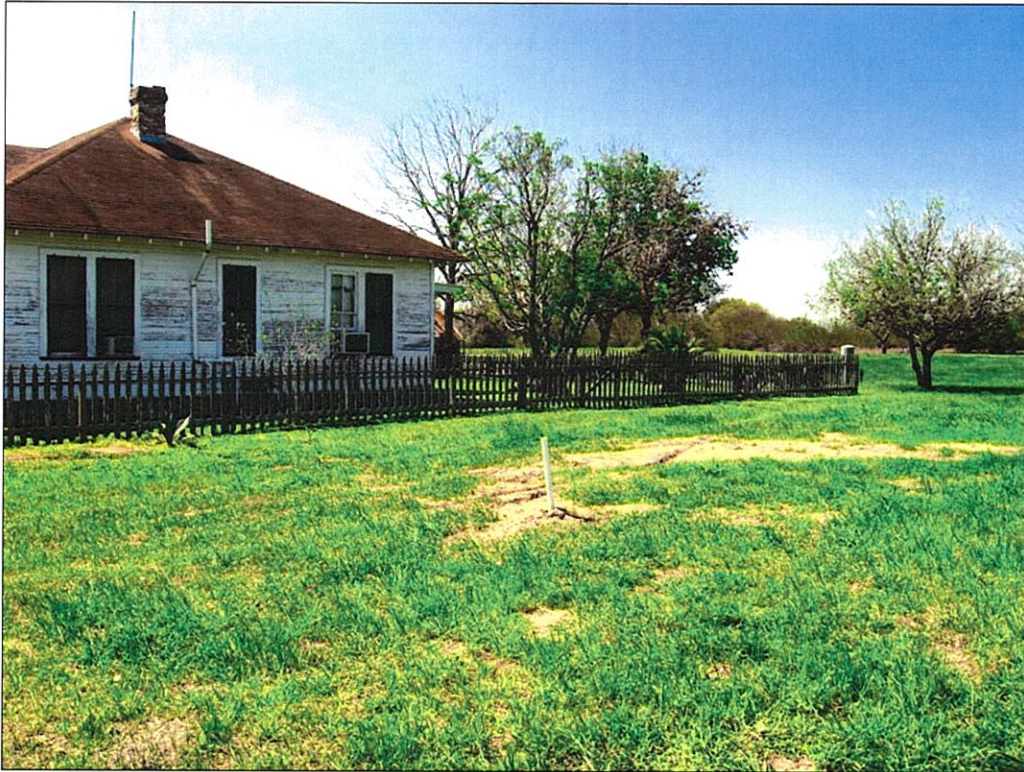
Photo 4: Drilling location near Braquet house 3-19-08.

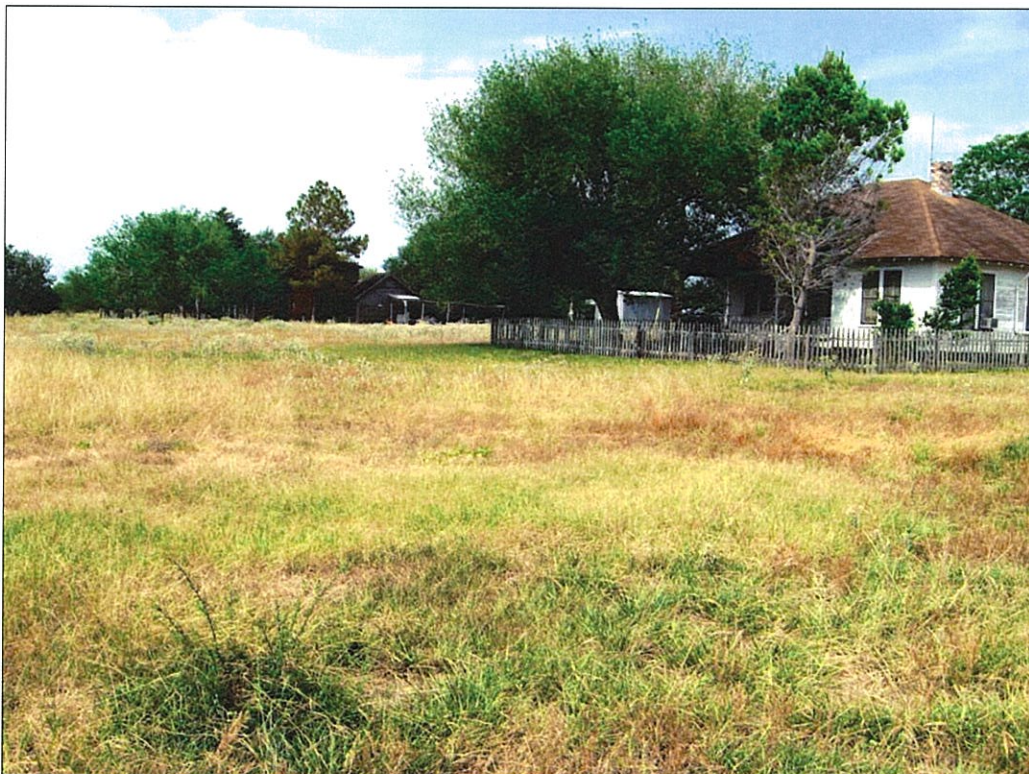
Photo 5: Houses on Braquet property with little evidence of exploration activity on 6-25-09.

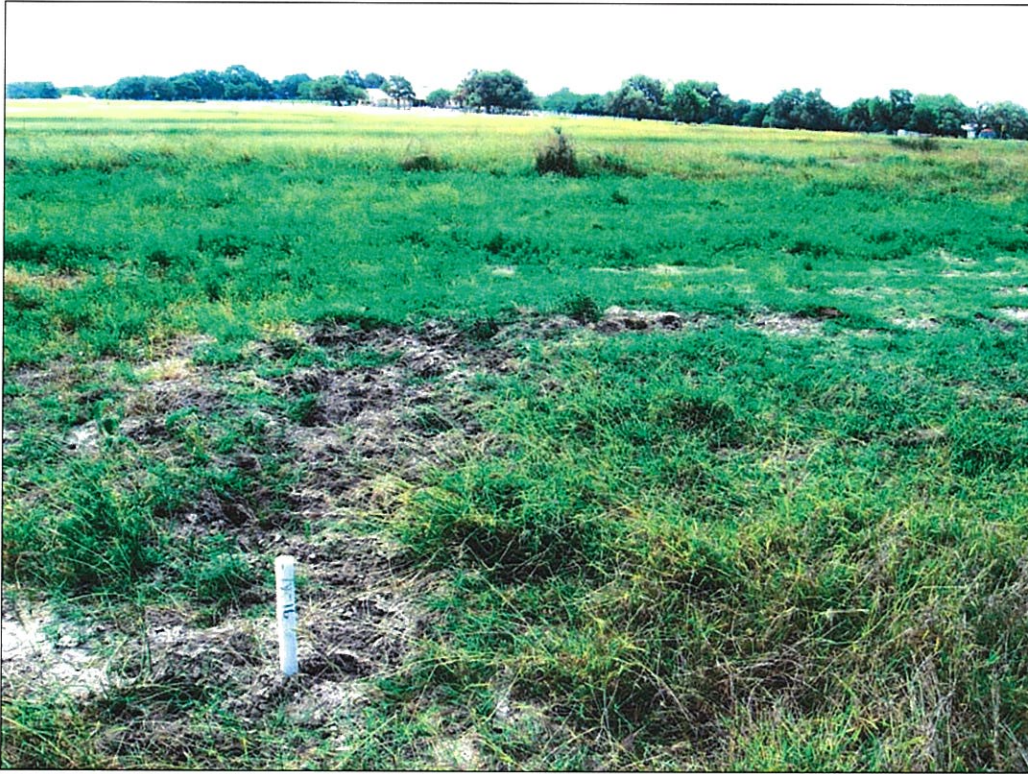
Photo 6: Borehole N-16 with Ander church and cemetery visible on horizon on 5-21-08.

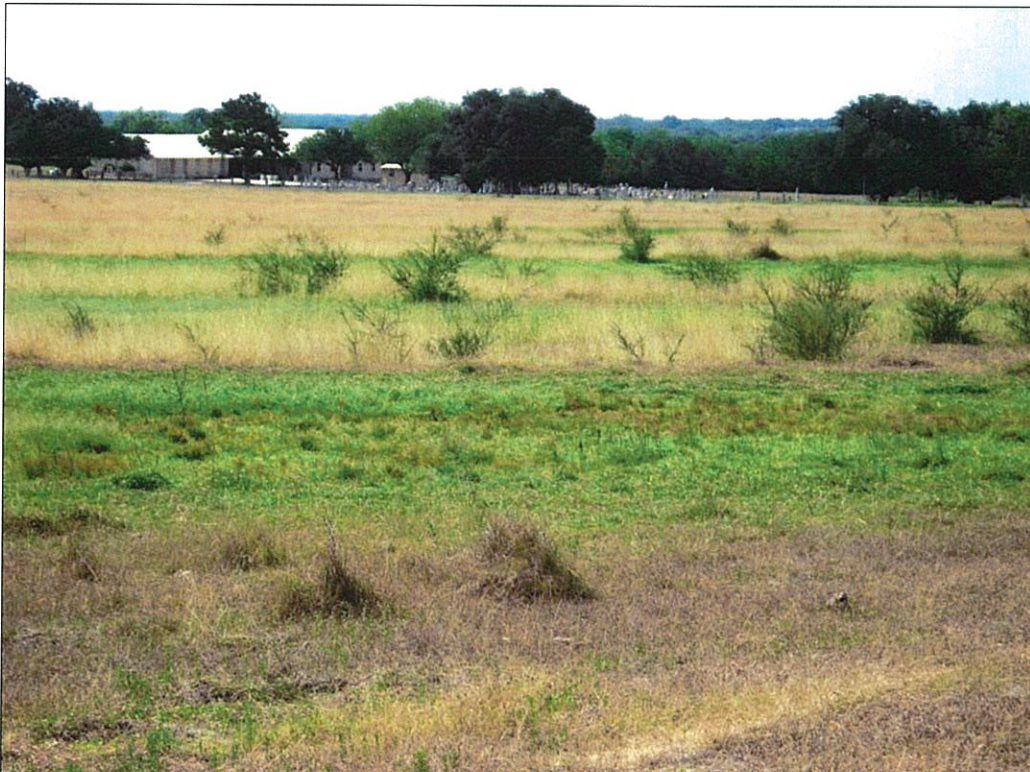
Photo 7: Ander church and cemetery, 6-25-09, with little evidence of exploration activity visible.

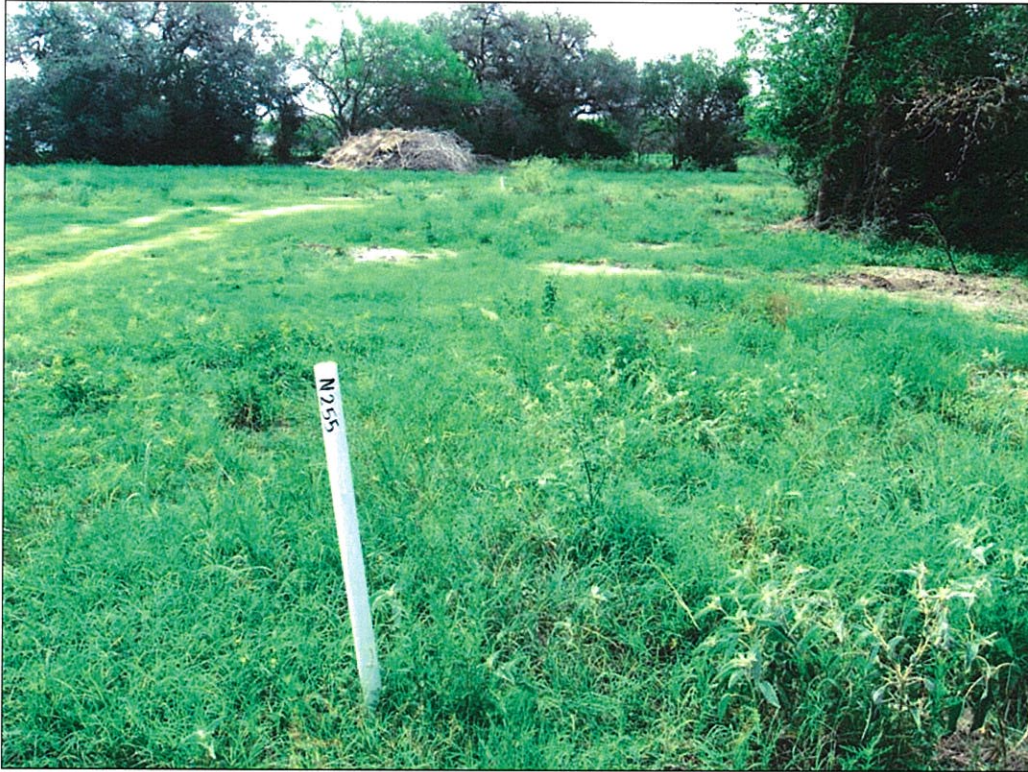
Photo 8: Boreholes N-255 and CC-4 on 7-16-08.

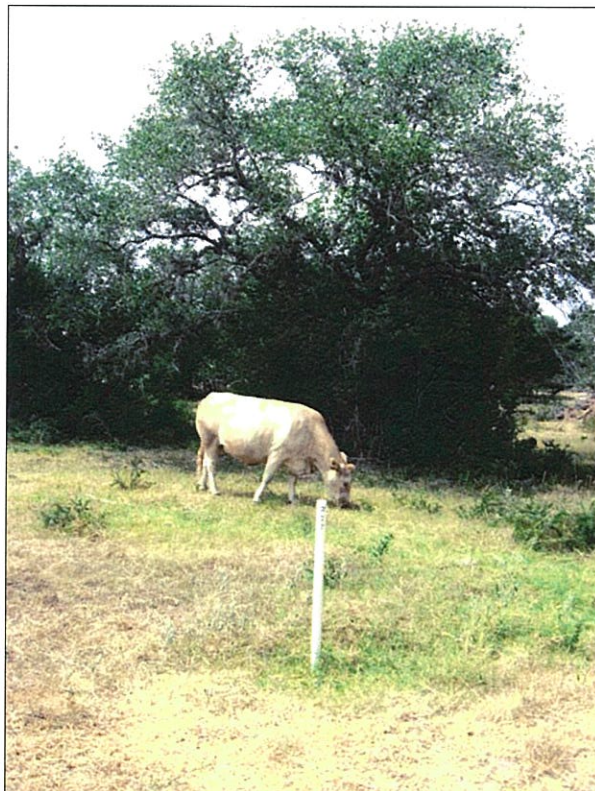
Photo 9: Borehole N-255 location 6-25-09.

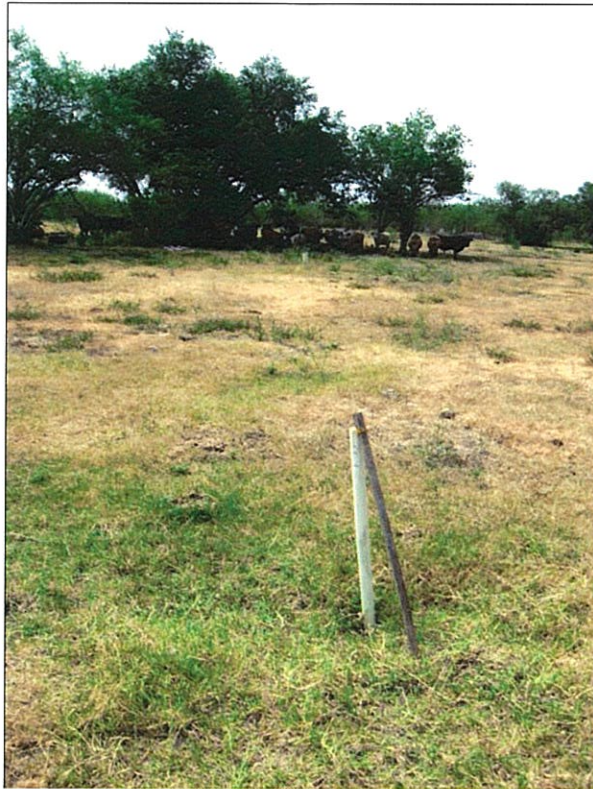
Photo 10: Site restoration at borehole CC-4 on 6-25-09.
